## **Sidewalk Assessment Restoration Process**

Sidewalk Assessment Restoration Process SAFE027  
Owner: RMS Director

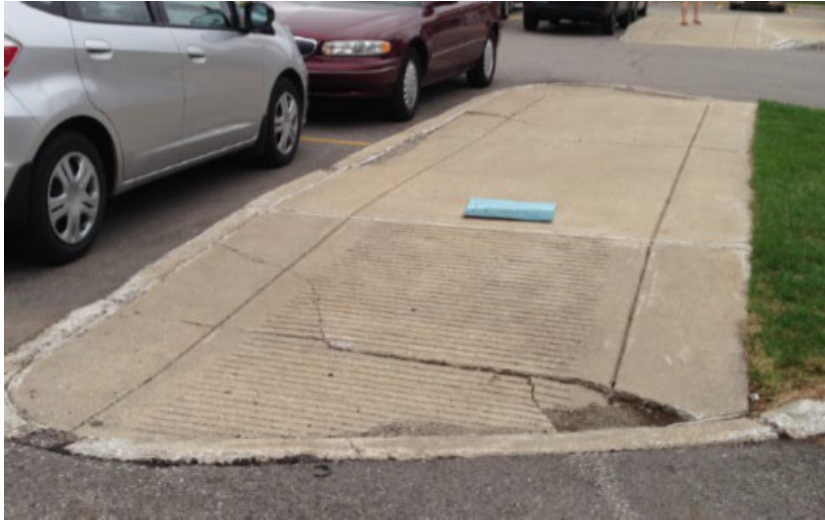
Picture 1: Curb Ramps

- Settlement, depressed areas, or inadequate drainage
  - Review bottom of ramp for signs indicating standing-water or inadequate drainage.

- Level changes or gaps at curb ramp transitions between drive, sidewalk, and gutter or at top of curb ramp transition to sidewalk.
  - Review all transitions for level changes and/or gaps
- Elevated cracks or deteriorated sections of curb ramp

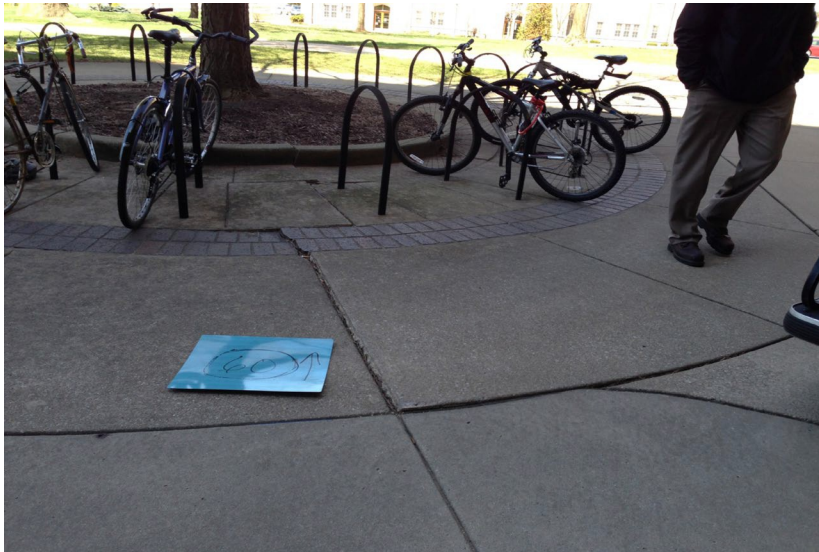
Picture 2: Level Changes at Sidewalk-to-Pavers

- Sidewalks and plazas
  - Look for settlement of pavers at transitions between pavers and concrete
- Service drives or crosswalks at parking lot entrances
- Curb-to-sidewalk transitions
  - Sidewalk to landscaping or lawn areas. Transition changes may occur from soil erosion, inadequate drainage, traffic ruts, deteriorated mulch beds, etc.
- Various material transitions
  - Review level changes where various material changes occur such as: asphalt-to-concrete, concrete-to-pavers, stone-to-curb, etc.

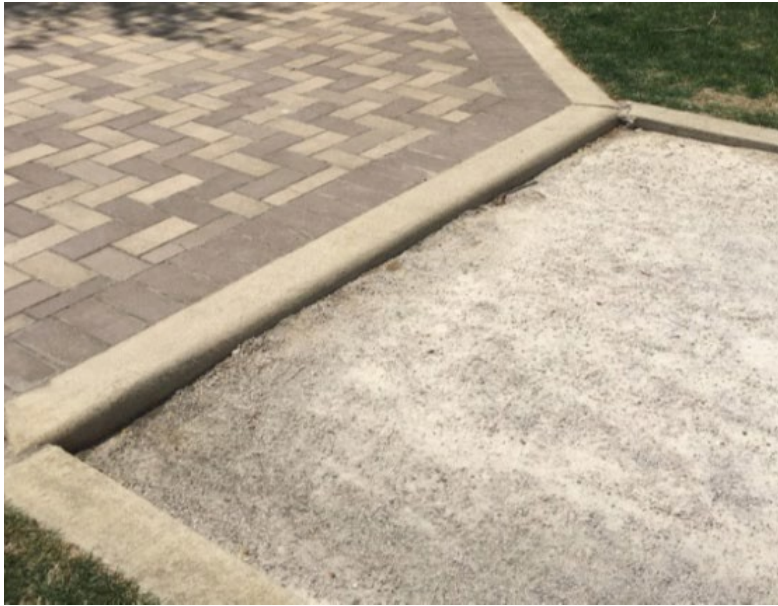
Picture 3: Level Changes at Dissimilar Materials

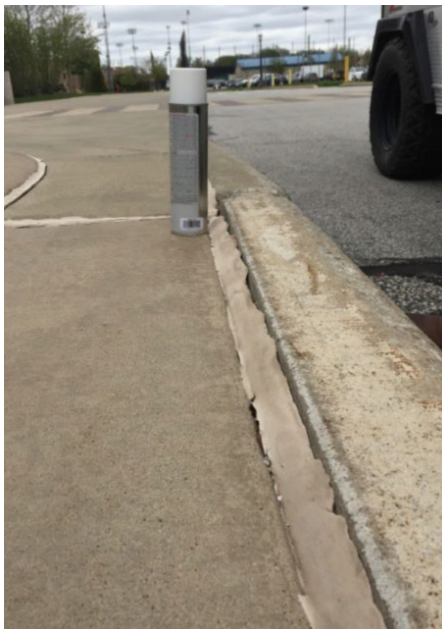
Picture 4: Level Changes at Curb-to-Sidewalk

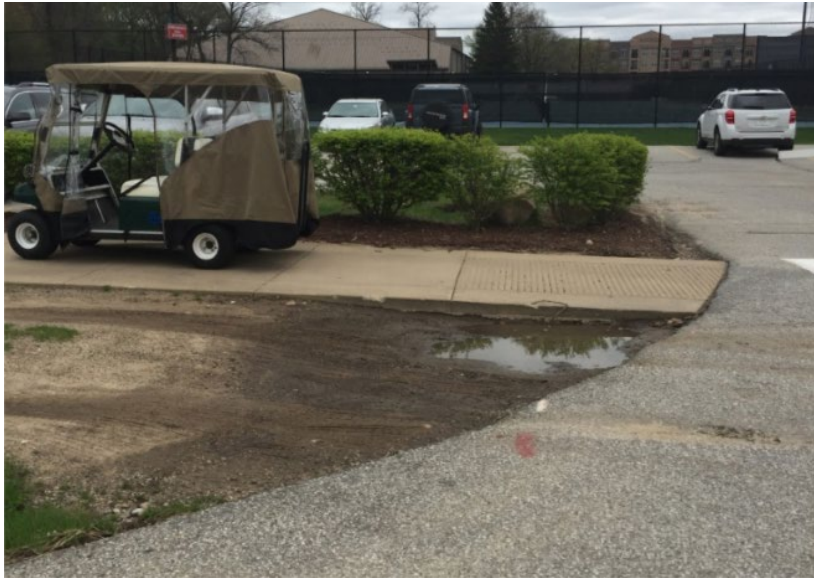
Picture 5: Level Changes Adjacent to Sidewalk

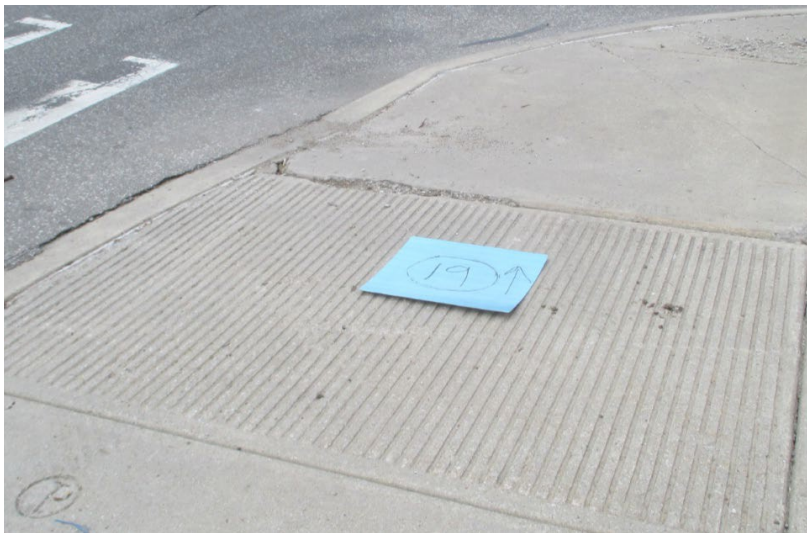
Picture 5: Deteriorated Sidewalks

5.2. Deteriorated walks, cracks, or gaps at asphalt pavement walks and concrete or paver walks.
